**MUNICIPAL SEPARATE STORM
SEWER SYSTEM (MS4)
COMPLIANCE AUDIT**

**STATE OF CALIFORNIA,
DEPARTMENT OF TRANSPORTATION**

**REPORT DATE:
February 26, 2010**

**EVALUATION CONDUCTED:
October 5–7, 13–14, and 21–22, 2009**

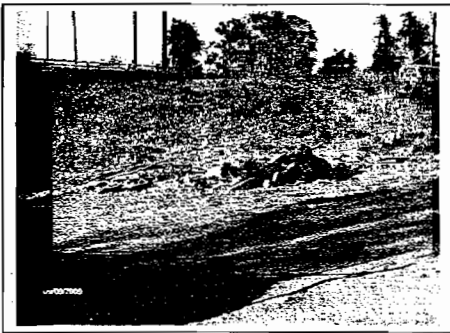
<p>11. Construction generated waste should periodically be removed and hauled away.</p>	<p>12. Construction generated waste should periodically be removed and hauled away.</p>

Exhibit 7. Sunol Grade/Route 680 Roadway Rehabilitation Project—Photograph 12 above corresponds to the area shown in Appendix E, Site Visit No. 11, Photograph 5 of this audit report.

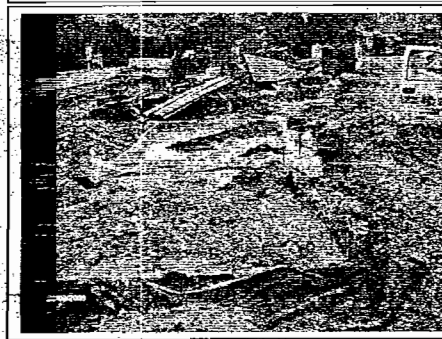
<p>9. It was recommended to install an entrance and exit at this location if it is going to be used as an entrance and exit.</p>	<p>10. Both of these washouts are leaking should be removed and replaced.</p>

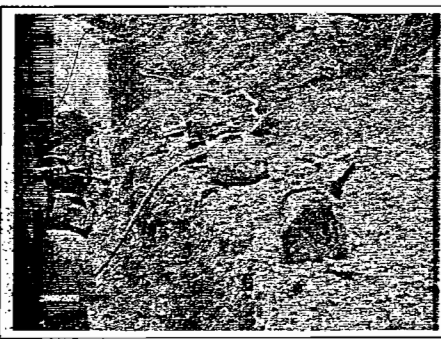
<p>11. Gas containers and pipe soup should be in the back of pick up or secondary container.</p>	<p>12. 5 gallon bucket has oil and two 55 gallons have some curing compound it it should be stored in secondary</p>

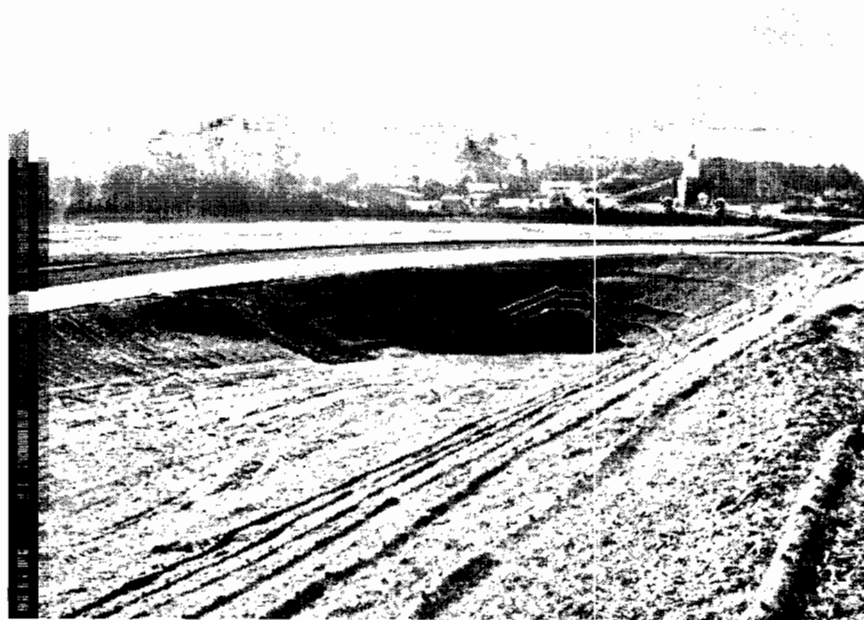
Photograph 2. Alton Interchange Project – Combination of multiple erosion and sediment controls

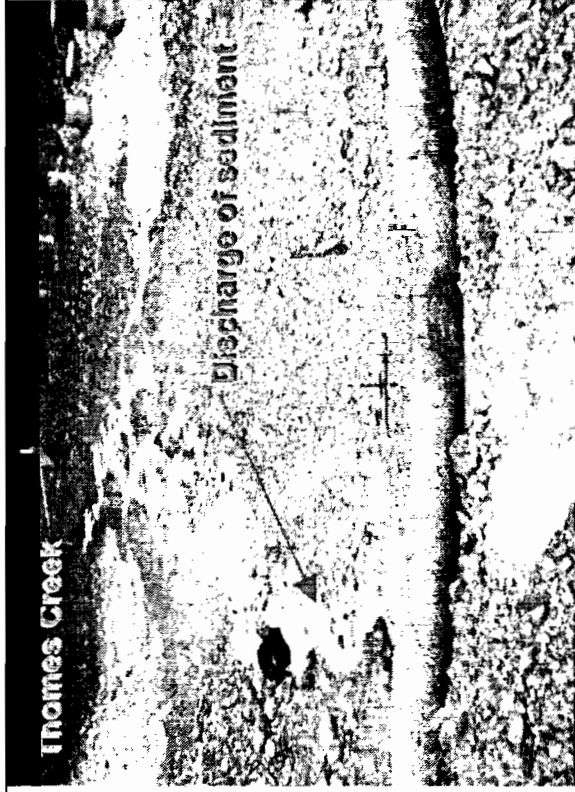
Photograph 9—Adequate BMPs were not implemented to prevent the discharge of sediment to Thomas Creek

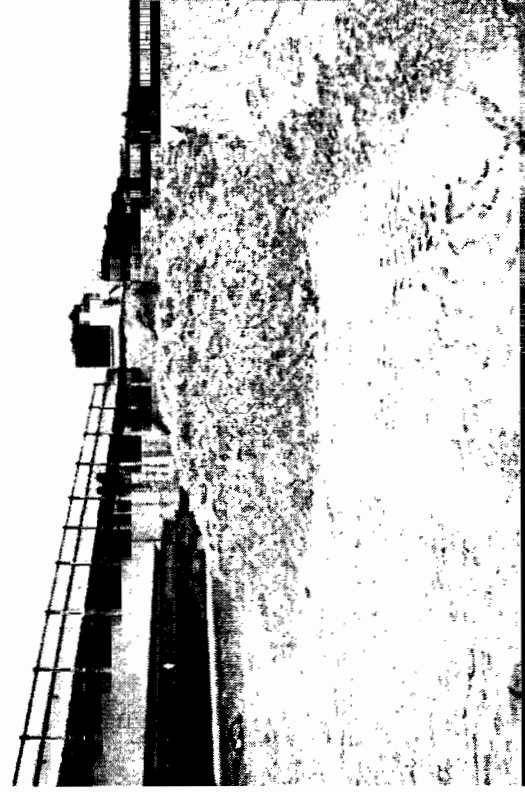
Photograph 11— Soil stockpile without BMPs

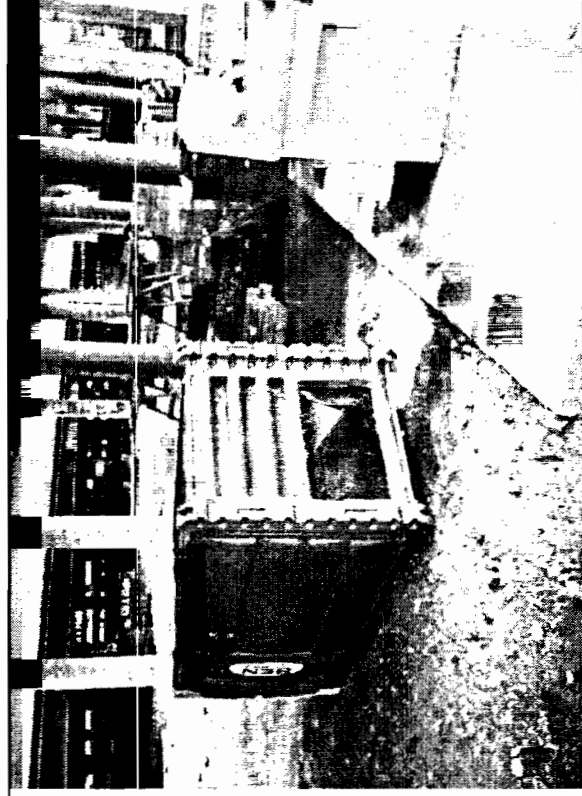
Photograph 12 – View of portable toilet blown over under Thomas Creek bridge

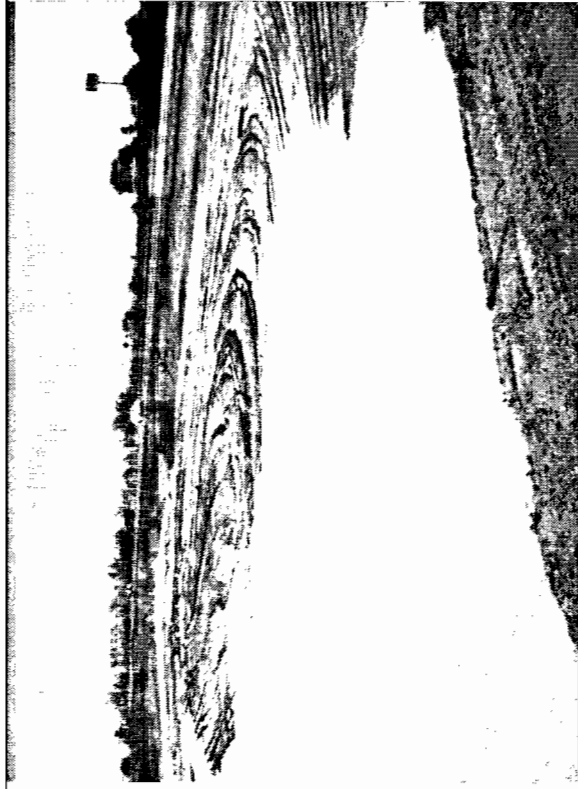
Photograph 1 – View of unstabilized sediment basin and embankment slopes

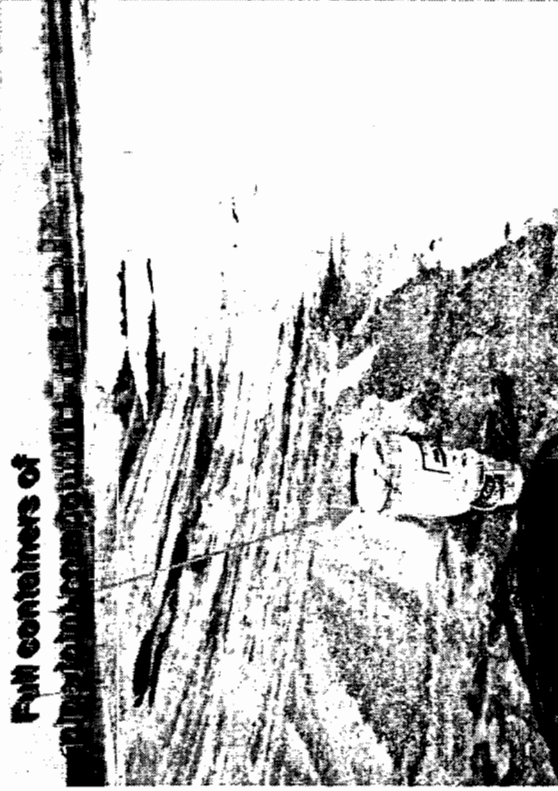
Photograph 7—Pipe joint compound located in the eastern sediment basin

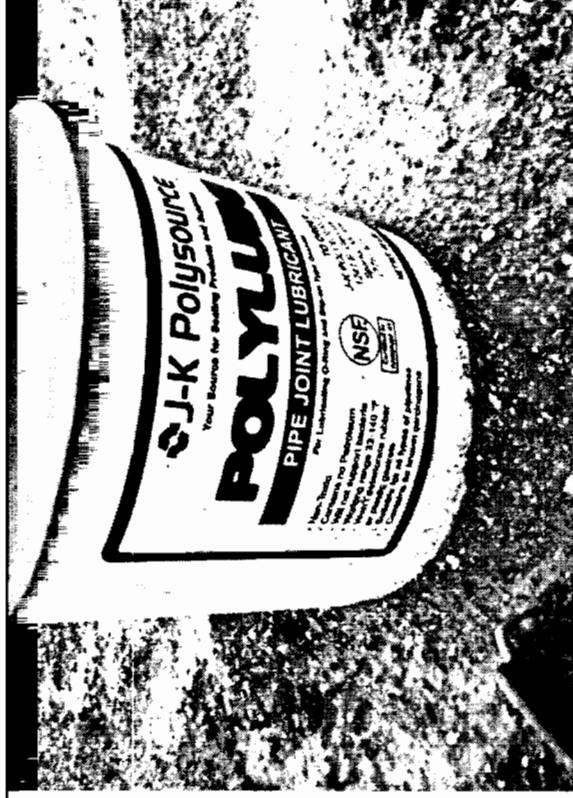
Photograph 8 – Close-up view of the full container of pipe joint compound in the eastern sediment basin

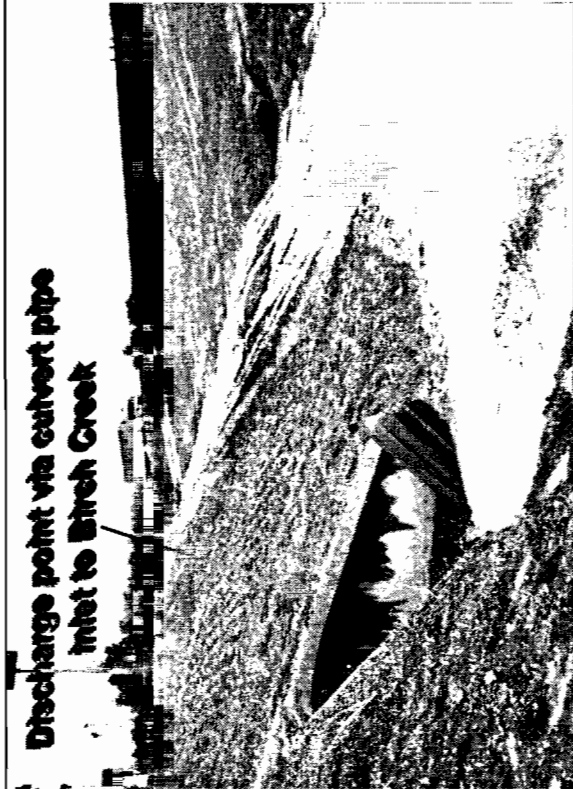
<p>Discharge point via culvert pipe inlet to Birch Creek</p>

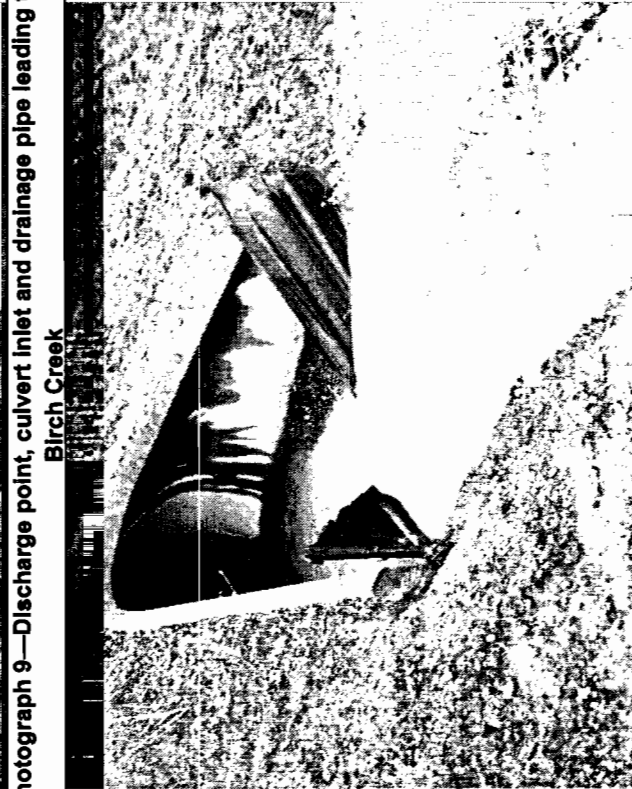
<p>Photograph 11— Collapsed silt fence BMP and discharge of sediment laden runoff</p>

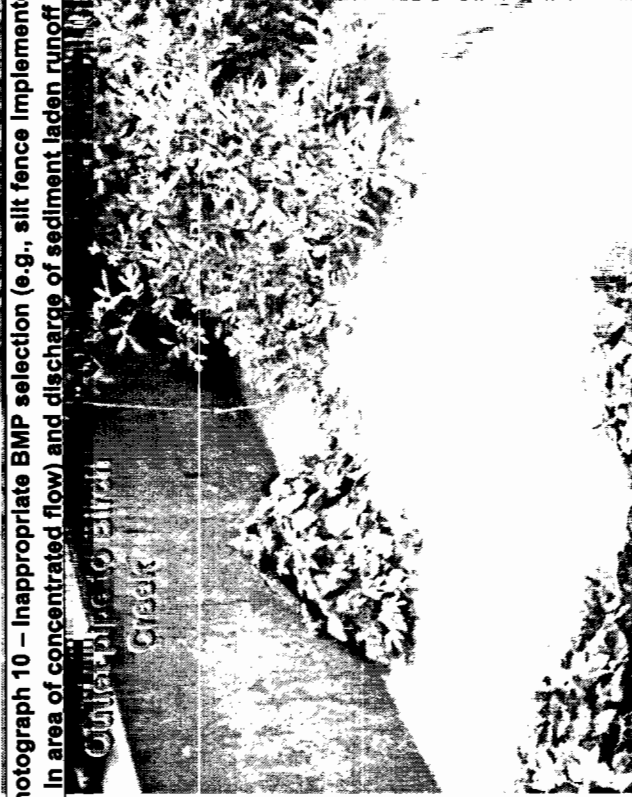
<p>Photograph 12 – View of outlet pipe from Photograph 11 leading to Birch Creek</p>

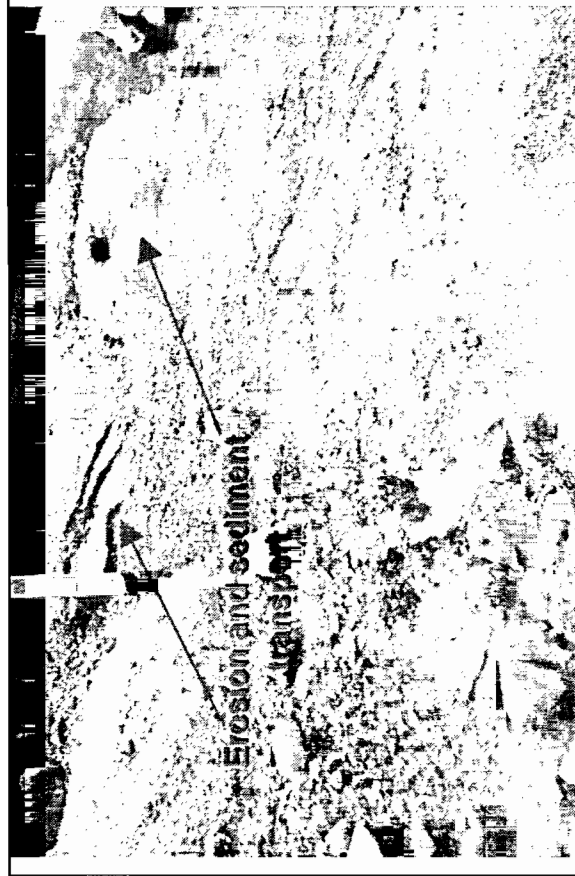
Photograph 5 – Lack of adequate BMPs to prevent discharge of sediment to the roadway

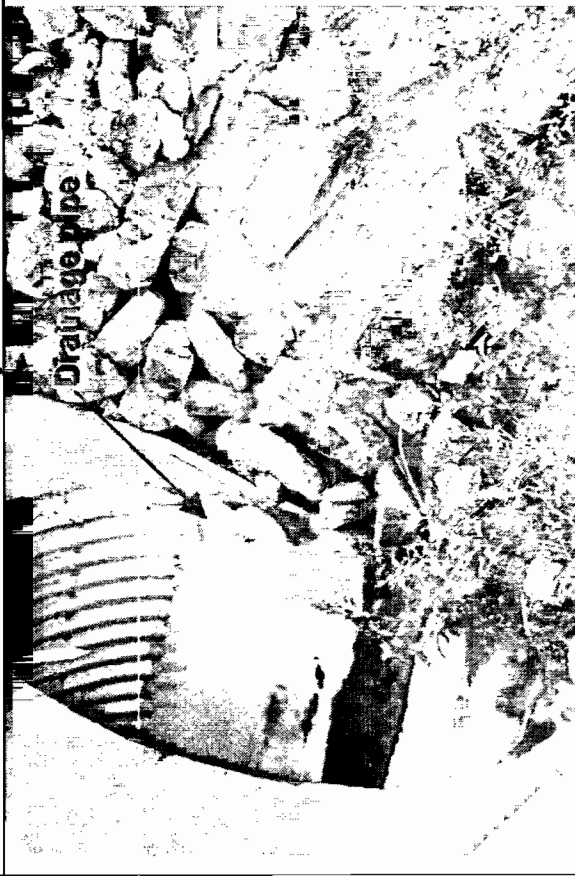
Photograph 7 – Sediment accumulation at down-gradient drainage pipe Inlet

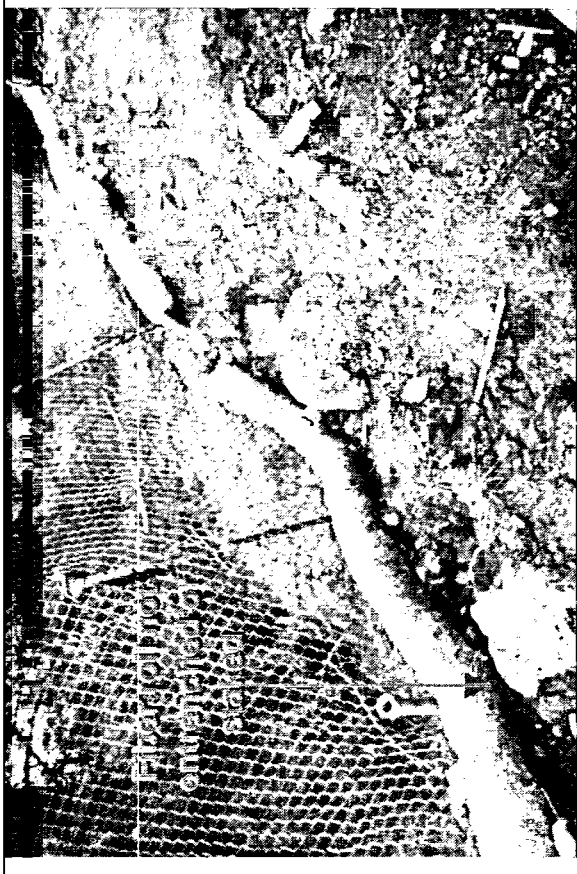
Photograph 3 – Example of fiber roll not entrenched or staked into the ground

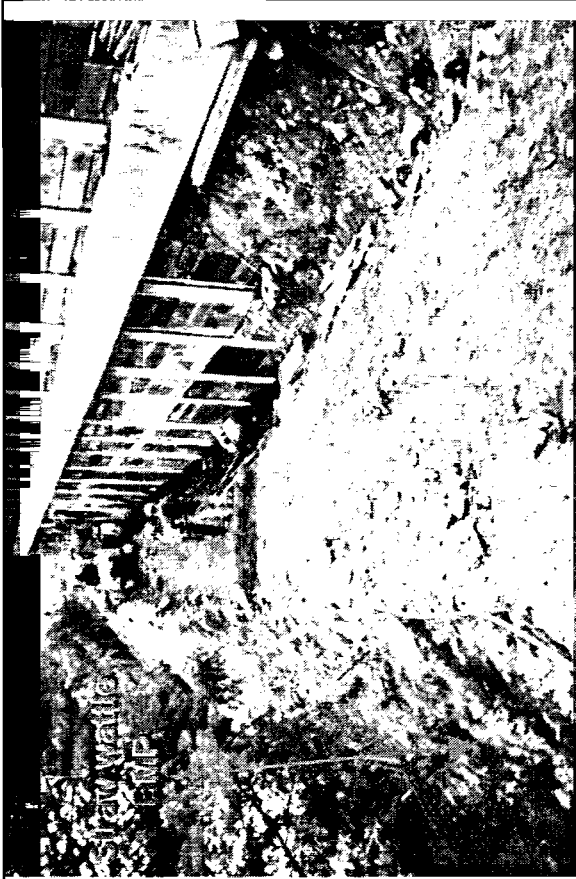
Photograph 2 – Example of straw wattle BMP implemented down-gradient of disturbance and retaining wall construction

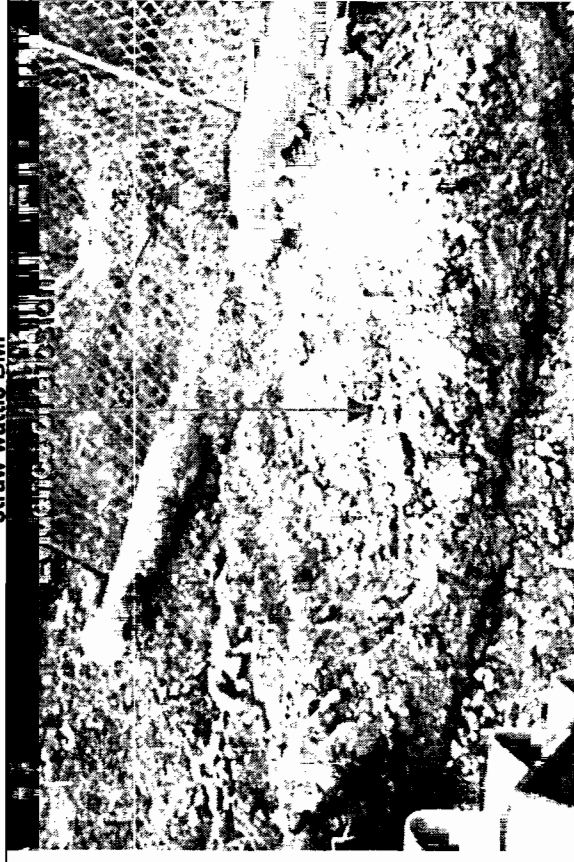
Photograph 7— Undercut section of straw wattle BMP and evidence of erosion

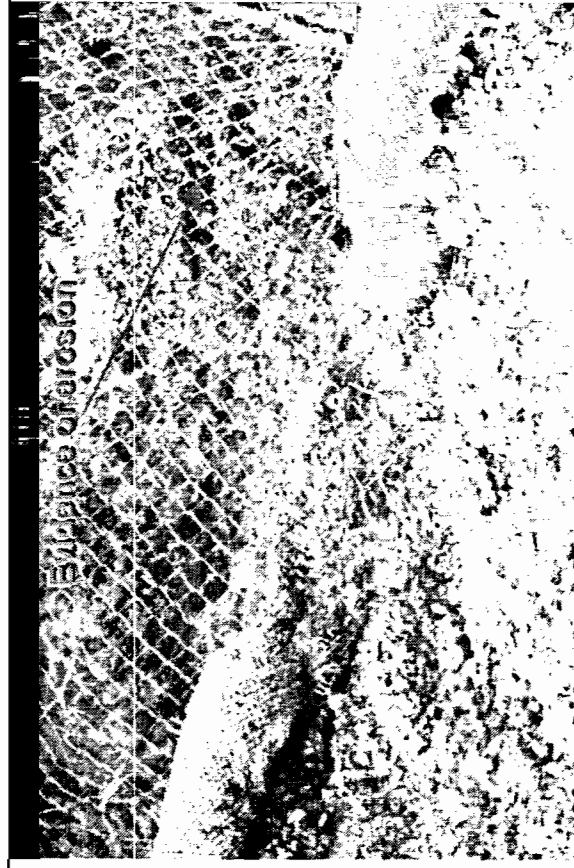
Photograph 8 – Closer view of straw wattle and erosion pictured in Photograph 7

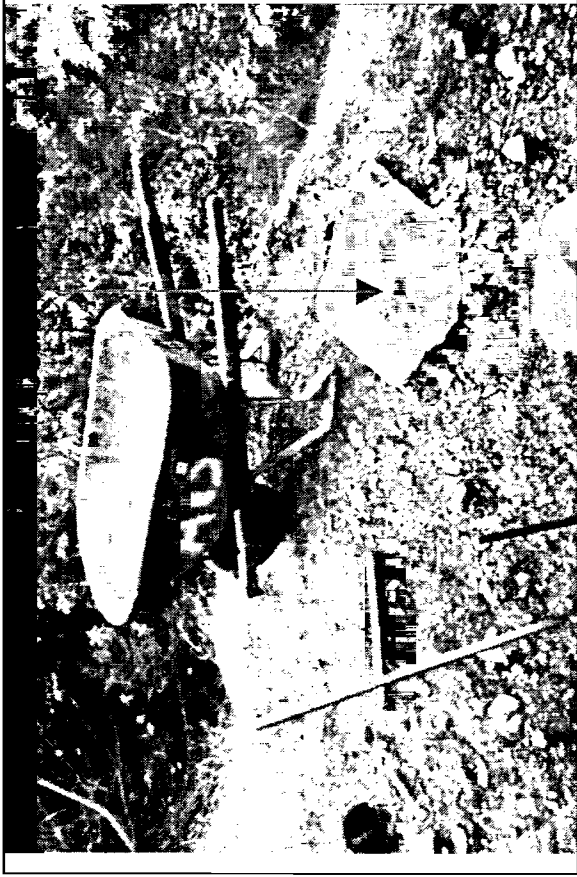
<div> Photograph 10— Concrete waste and container in staging area (Note: Straw wattle BMP not staked or entrenched into ground) </div>

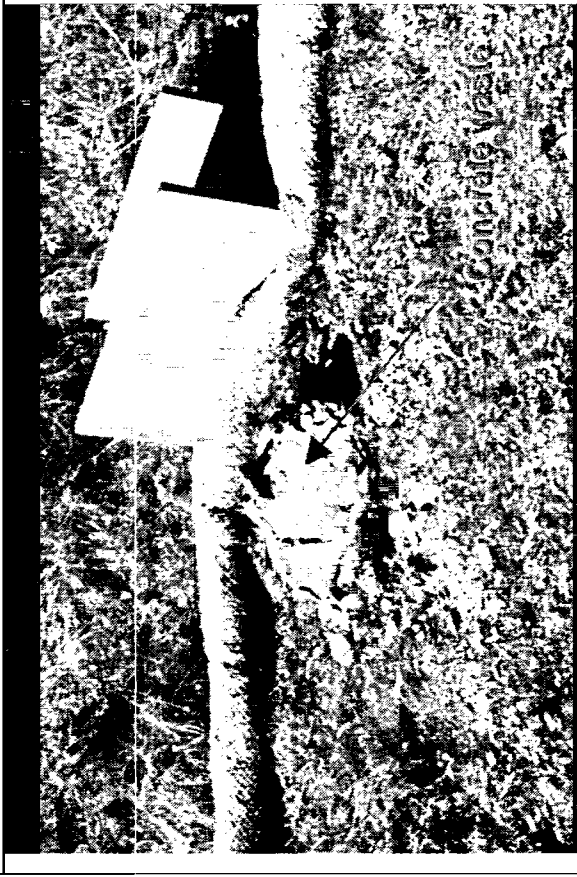
<div> Photograph 12— Stockpile in staging area without BMPs for containment or coverage </div>
<div> Photograph 11— Concrete waste near concrete waste container in staging area (Note: Straw wattle BMP not staked or entrenched into ground) </div>

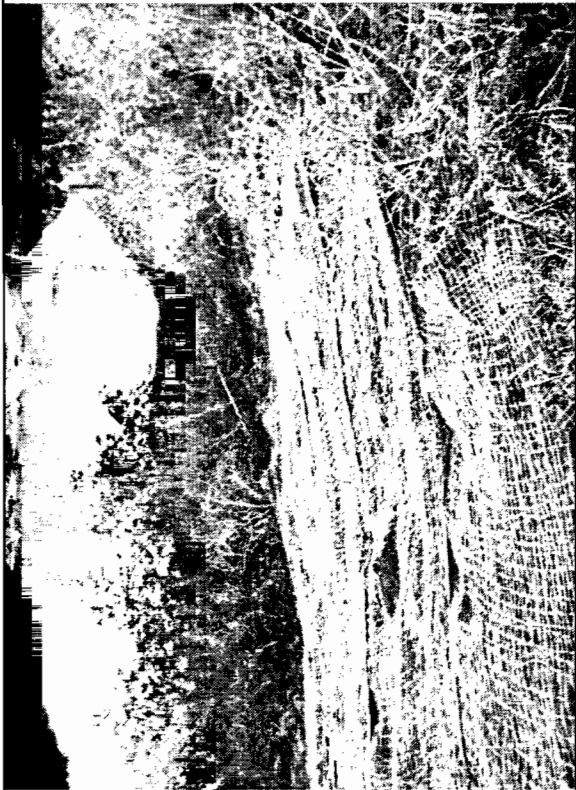
<p>Photograph 2 – Close-up of Photograph 1 looking down-gradient.</p>

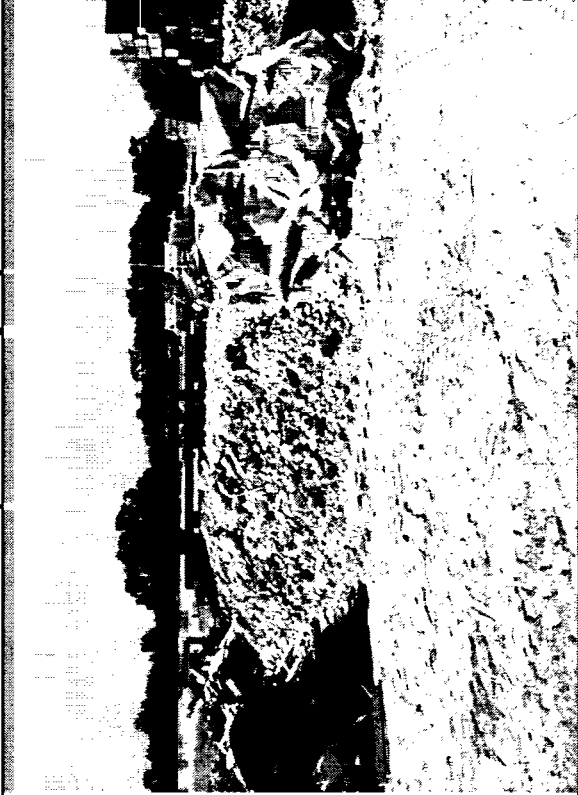
<p>Photograph 7 – Drainage outlet at base of unstabilized slope shown in Photograph 6.</p>	<p>Photograph 8 – Uncontrolled/uncontained concrete waste</p>

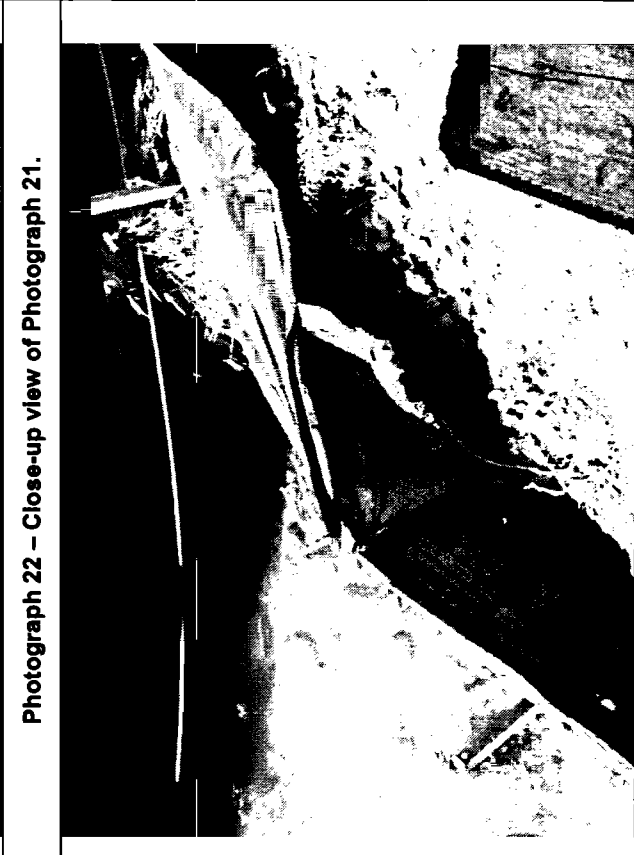
<p>Photograph 22 – Close-up view of Photograph 21.</p>
 	<p>Photograph 23 – Silt Fence collapsed in areas and not properly maintained. Note large unstabilized slope area upgradient.</p>
 	<p>Photograph 24 – Silt Fence not properly entrenched to retain sediment adjacent to Yankee Slough waterway</p>

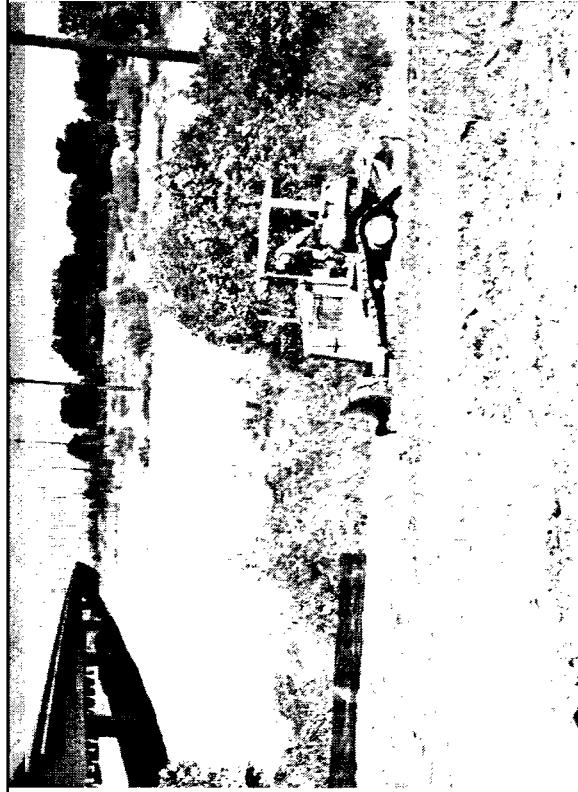
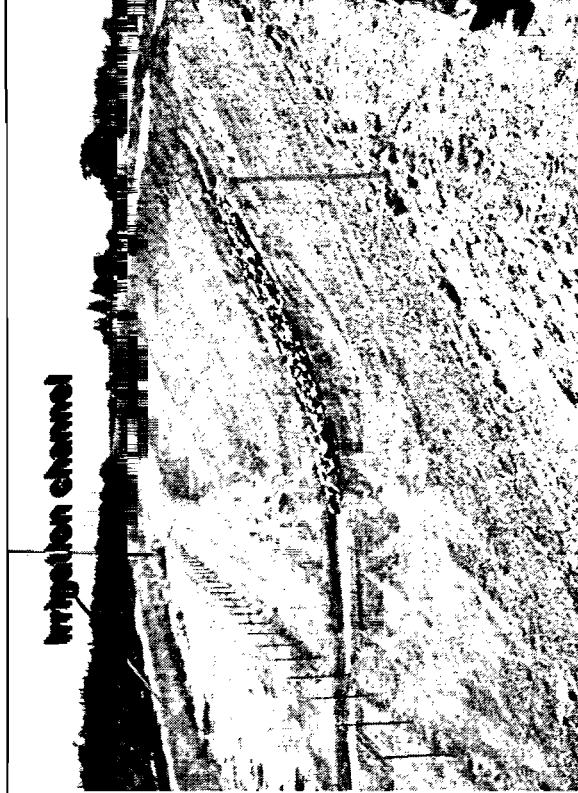
<p>Photograph 25 – SF not adequately implemented for all land disturbing activities to prevent the discharge of sediment to Yankee Slough</p>	<p>Photograph 26 – Large expanse of disturbed slope area with only rock and no perimeter BMPs.</p>

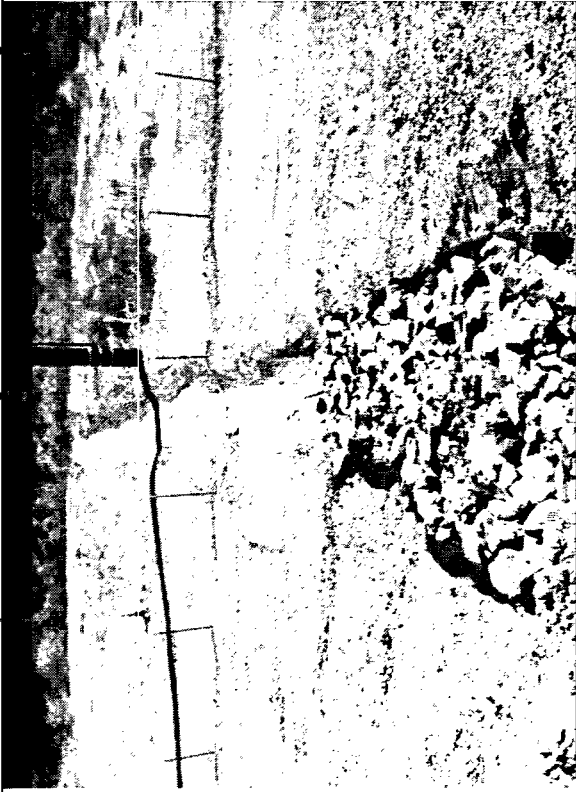
<p>Photograph 27 – Slope drainage channel which drains to Irrigation channel</p>	<p>Photograph 28 –Previous erosion and sediment accumulation draining to Irrigation channel. Flow dissipators do not extend entire length.</p>

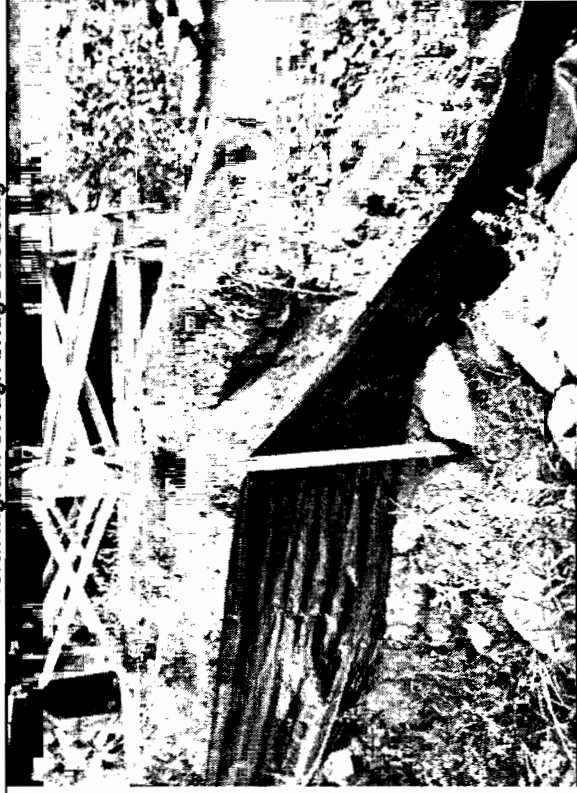
Photograph 11 – Silt Fence BMPs not properly installed (e.g., not entrenched) or maintained (e.g., collapsed) adjacent to Auburn Ravine

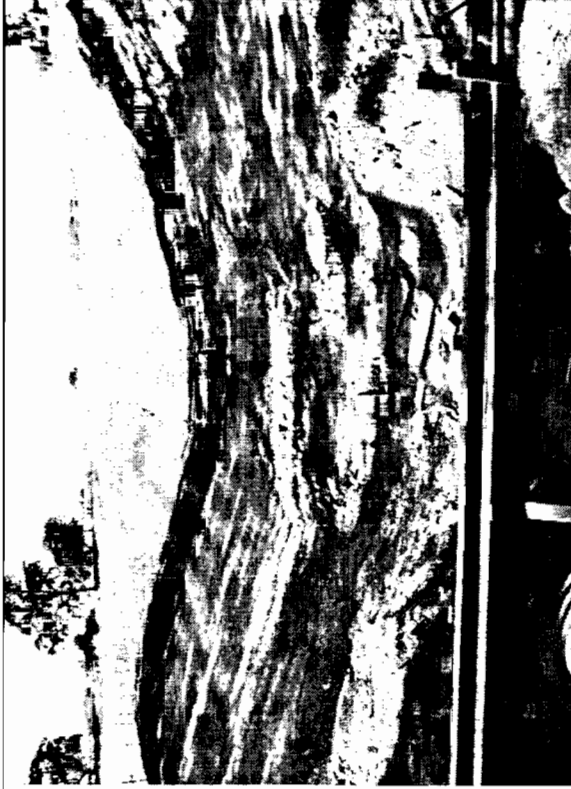
Adequate structural and non-structural BMPs were not implemented in the drainage swale conveyance channels located up-gradient of South Ingram Slough (see Photograph 8) and Auburn Ravine (see Photograph 17). BMPs had not been implemented to prevent erosion from run-on to the swale slopes, and concentrated flow along the bottom of the swale. As a result, there was a potential for erosion and subsequent discharge from these drainage swale conveyance channels to South Ingram Slough and Auburn Ravine, respectively.

Photograph 17 – Upgradient areas of disturbance associated with pollution prevention BMP unstabilized. Drains to Auburn Ravine.

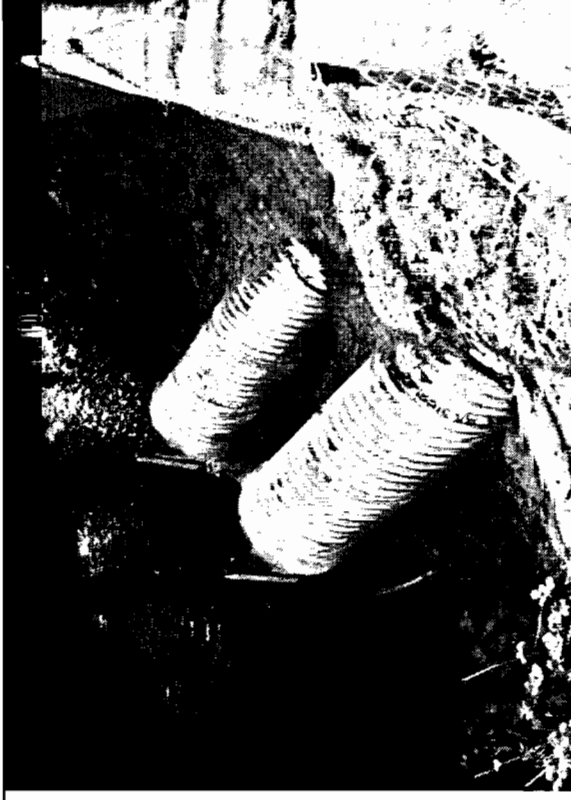
Photograph 18 – Disturbed slope area adjacent to pollution prevention BMP outlet pipes adjacent to Auburn Ravine.

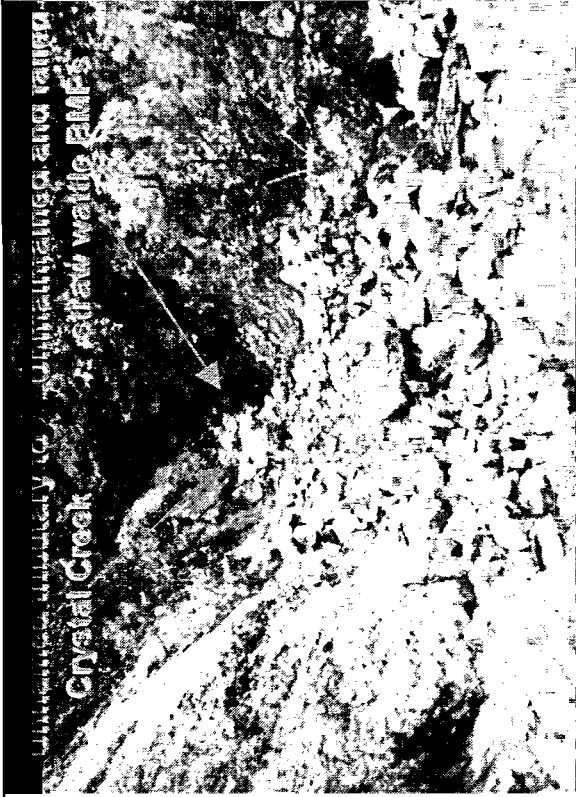
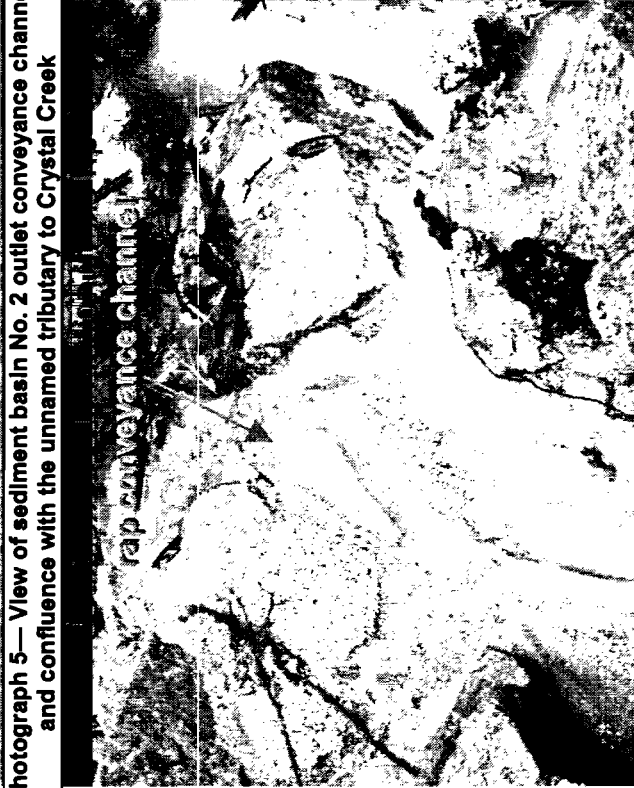
In addition to the up-gradient disturbed areas contributing sediment to and beyond the field constructed basins No. 1 and No. 2, adequate BMPs were not implemented below the basin No. 2 rip-rap outlet conveyance channel (see Photograph 6), at the base of the field constructed sediment basin No. 2 outer embankment slope (see Photographs 13 through 15), below field constructed sediment basin No. 1 culvert outlet pipe (see Photograph 16), and on disturbed slope areas adjacent to the rip-rap outlet conveyance channel. It should be noted that the sediment basins were field constructed, as provided by Caltrans District No. 2 representatives, and it was not known whether the basins were designed and constructed according to the Caltrans Pollution Prevention Design Guide (PPDG).

<p>Field constructed Sediment Basin No. 2 outlet conveyance channel</p>

<p>unnamed tributary to Crystal Creek</p> <p>unnamed tributary to Crystal Creek</p> <p>straw wattle BMPs</p>

<p>rip-rap conveyance channel</p>

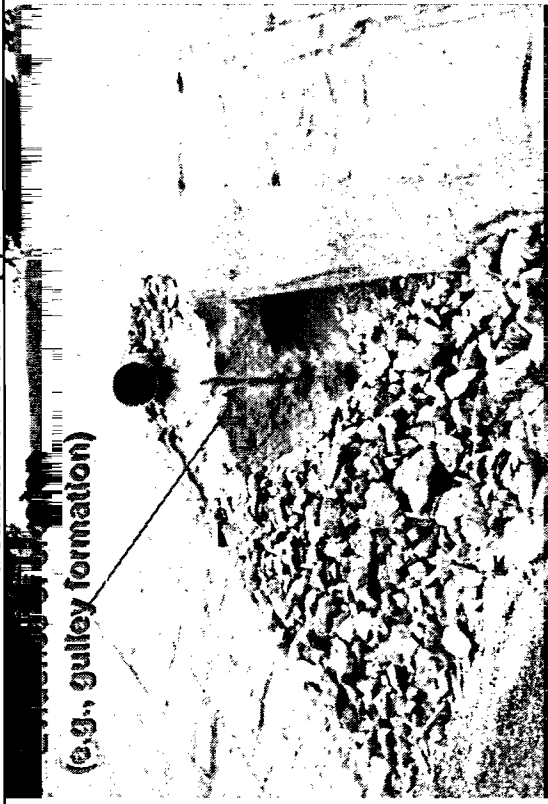
improper BMPs selection for an area of concentrated flow from the field constructed sediment basin No. 2 outlet conveyance channel (see Photographs 6 and 8). The silt fence BMPs implemented below the field constructed sediment basin No. 2 embankment slope were placed under a culvert pipe, had collapsed in areas, and evidence of sediment transport beyond the silt fence BMP to the unnamed tributary was observed (see Photographs 13 through 15). Adequate BMPs had not been implemented for flow dissipation below the field constructed sediment basin No. 1 culvert outlet pipe. Evidence of erosion (e.g., gulley formation) and embankment undercutting was observed (see Photograph 16). Furthermore, BMPs were not implemented for disturbed slope areas adjacent to the rip-rap outlet conveyance channel which drains to the unnamed tributary to Crystal Creek (see Photograph 17). As a result, there was a discharge of sediment to the unnamed tributary which subsequently drains to Crystal Creek. Prohibition A.1 of the Permit states the “discharge of runoff from construction sites containing pollutants which have not been reduced using BAT for toxic pollutants and BCT for conventional pollutants to waters of the United States is prohibited.”

<p>Evidence of the discharge of sediment beyond the silt fence BMP</p> <p>Silt fence BMP that collapsed</p>

<p>Evidence of field BMP (e.g., gulley formation)</p>	<p>Photograph 16 – Adequate BMPs were not implemented below field constructed sediment basin No. 1 culvert outlet pipe.</p>
<p>Photograph 15—SF BMPs were not adequately maintained (e.g., collapsed in areas) to prevent the discharge of sediment to the unnamed tributary.</p>

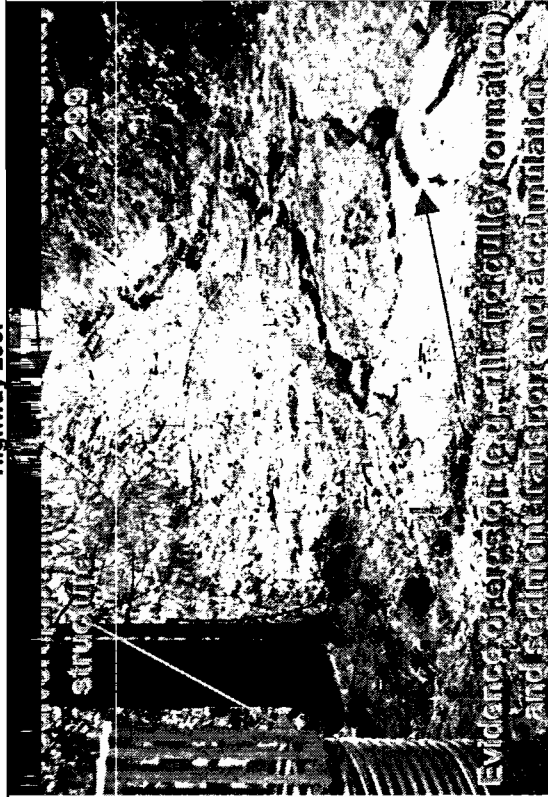
Adequate BMPs were not implemented for disturbed cut slope areas located adjacent to State Highway 299, which ultimately drain offsite via a culvert pipe inlet and drainage pipe leading to unnamed tributary to Crystal Creek. Specifically, adequate structural and non-structural BMPs had not been implemented for the disturbed cut slope areas (see Photograph 18), and evidence of erosion, cut slope failure and sediment transport were observed (see Photographs 18 through 20). As a result, there was evidence of sediment transport from the disturbed cut slope area to the adjacent State Highway 299 drainage swale which drains to the culvert pipe inlet area (see Photograph 20).

<p>Photographs 20 –Evidence of erosion (e.g. rill and gulley formation) and sediment transport from upgradient disturbed slope area (see Photo 18+19)</p>

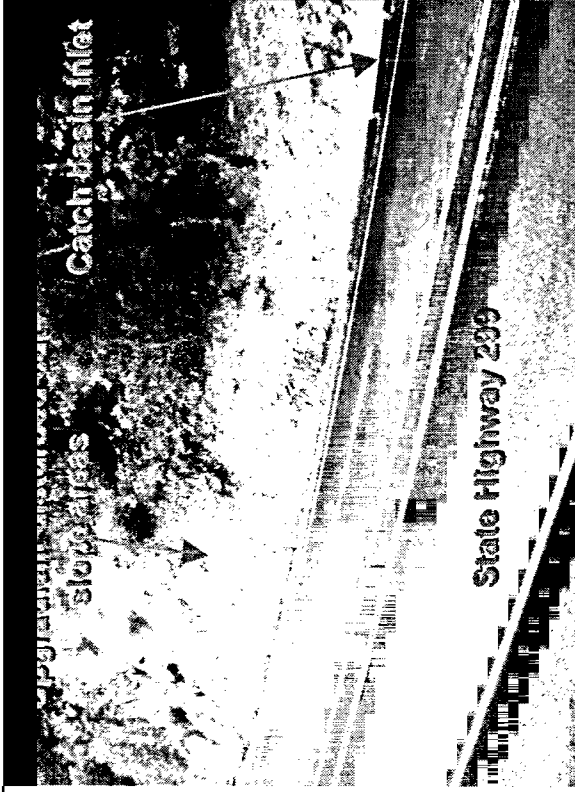
BMPs had not been implemented for catch basin inlets located in the flowline of the drainage swale associated with State Highway 299 roadway. Specifically, BMPs were not implemented to prevent the discharge of sediment to the catch basin inlets from up-gradient disturbed cut slope areas (see Photographs 21 and 22). As a result, there was a potential for the discharge of sediment to the catch basin inlet and associated culvert drainage pipe which subsequently drains to the unnamed tributary to Crystal Creek.

<p>Photograph 21—BMPs were not implemented to prevent the discharge of sediment from up-gradient disturbed cut slope areas to catch basin inlets.</p> <p>Photograph 22 – BMPs were not implemented to prevent the discharge of sediment from upgradient disturbed cut slope areas to catch basin inlets.</p>
---	---	--

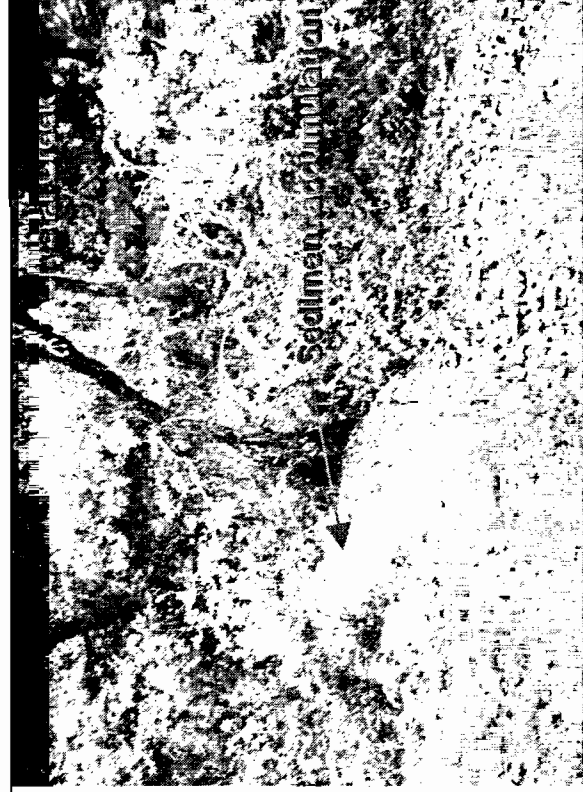
<p data-bbox="505 1094 537 1461">Sediment accumulation</p>

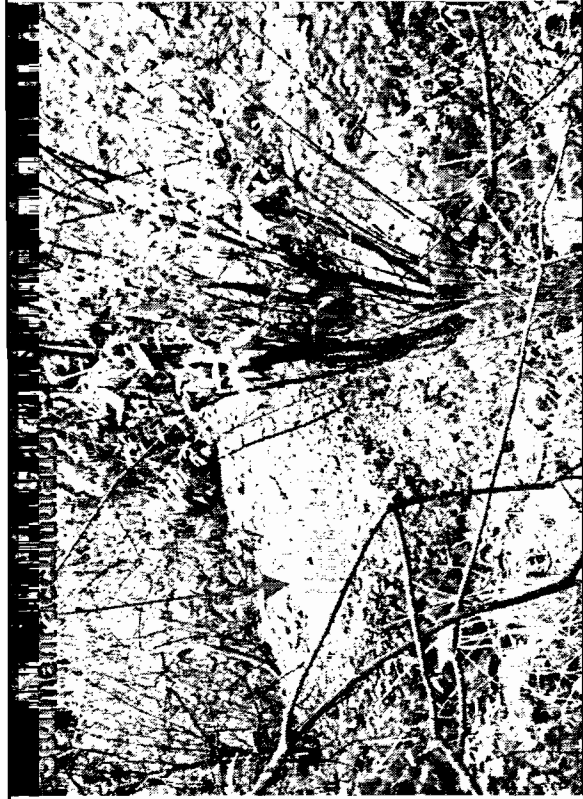
Photograph 6 – Close-up of sediment accumulation shown in Photograph 5

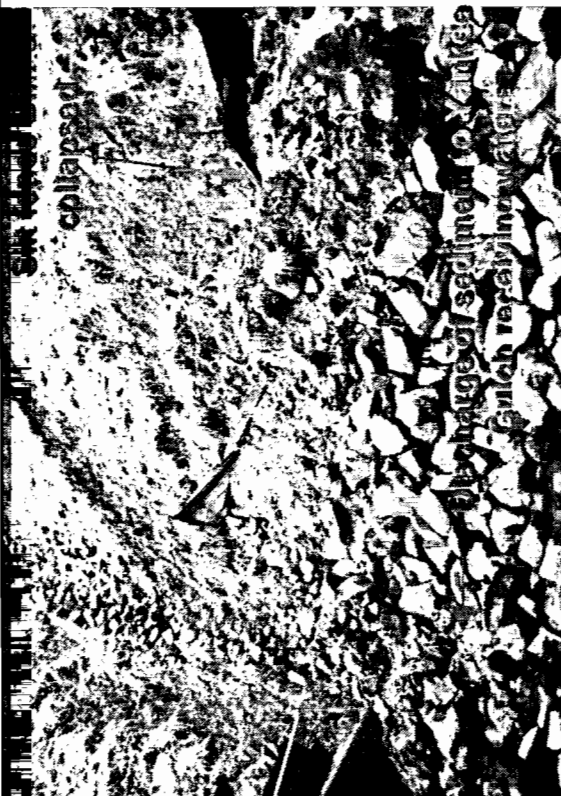
<p>Silt fence BMPs collapsed in areas and evidence of the discharge of sediment to Yankee Gulch</p>	Photograph 10 – Silt fence BMPs collapsed in areas and evidence of the discharge of sediment to Yankee Gulch	
		Photograph 12 – Close-up view of Photograph 11 depicting the discharge of sediment and sediment accumulation in Yankee Gulch

<p>Silt Fence BMPs collapsed</p> <p>Discharge of sediment to Yankee Gulch</p>

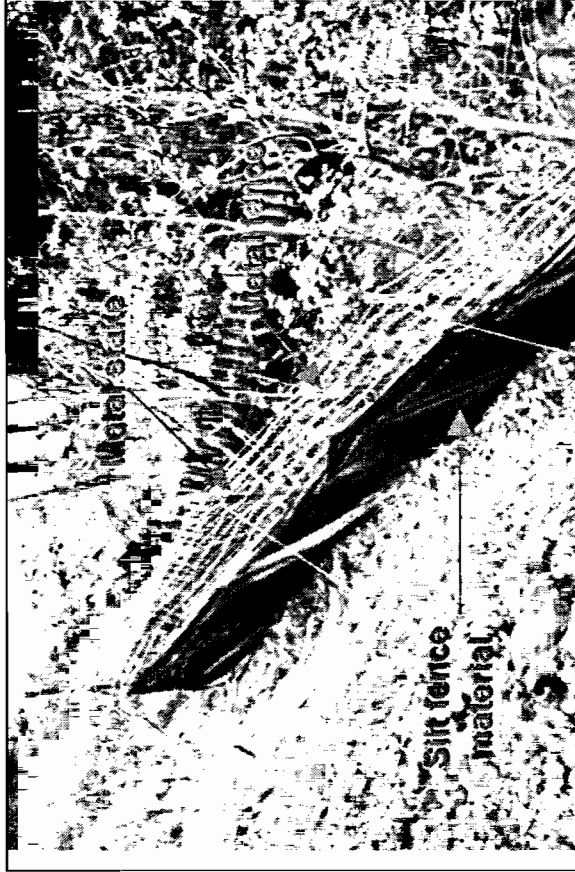
Photograph 1 – Example of reinforced silt fence BMP

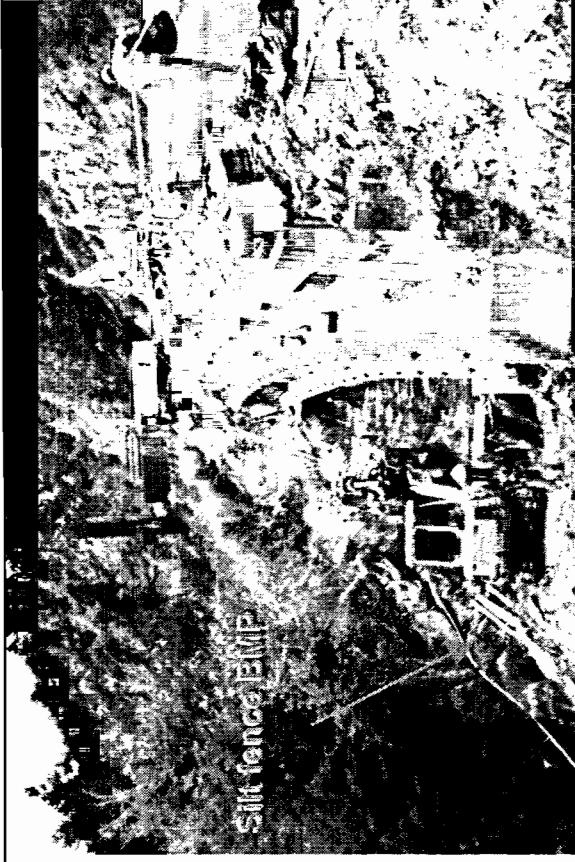
Photograph 2 – Example of silt fence BMP implemented down-gradient of disturbance and retaining wall construction

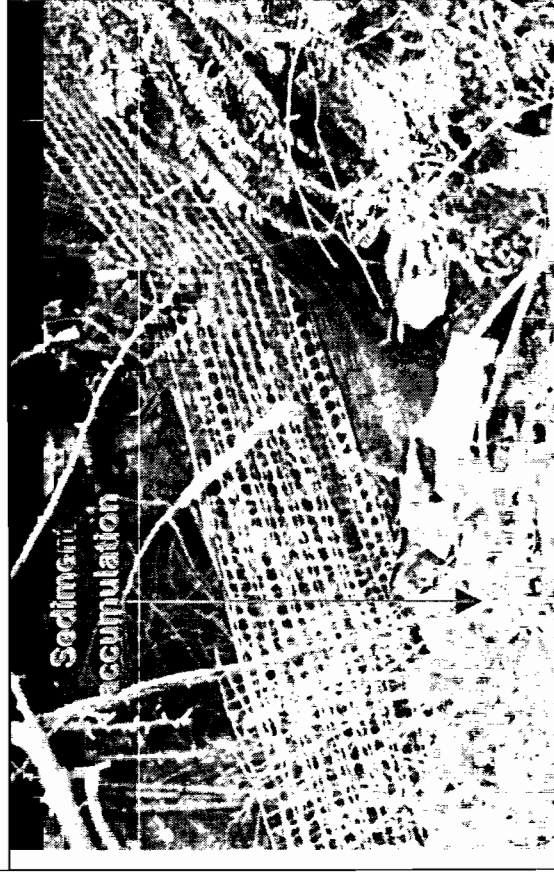
Photograph 3 – Example of sediment accumulation against silt fence BMP

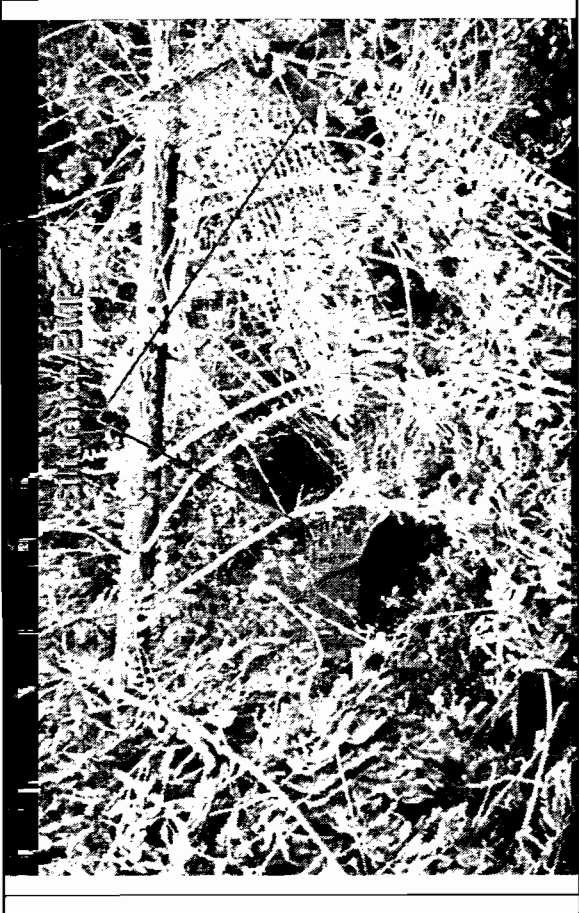
<p>Photograph 5— Another example of sediment accumulation and unmaintained silt fence</p> <p>Photograph 6 – Example of silt fence BMP partially covered by collapsed vegetation</p>

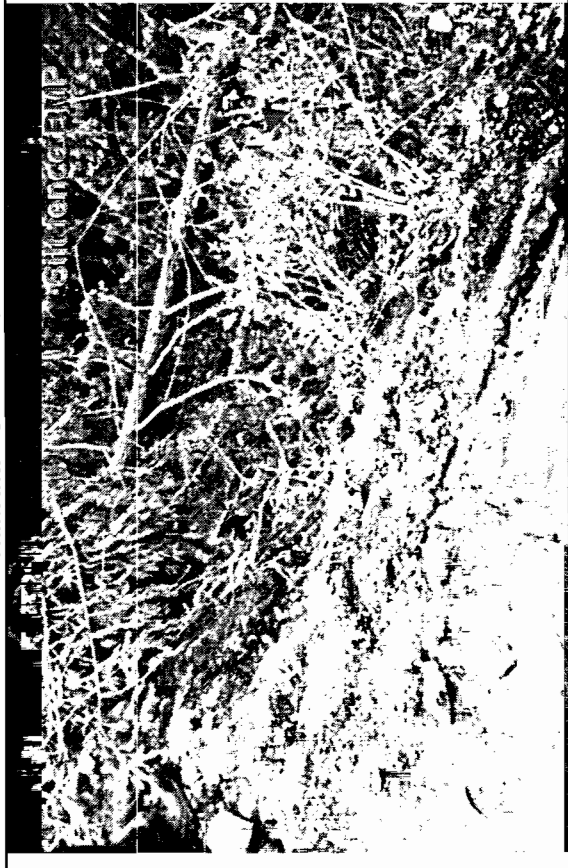
<p>Photograph 7— Another example of silt fence BMP partially covered by collapsed vegetation - view down slope to silt fence BMP</p> <p>Photograph 8 – 55-gallon drum of "Rock Drill 150" that is partially covered and not within adequate secondary containment</p>

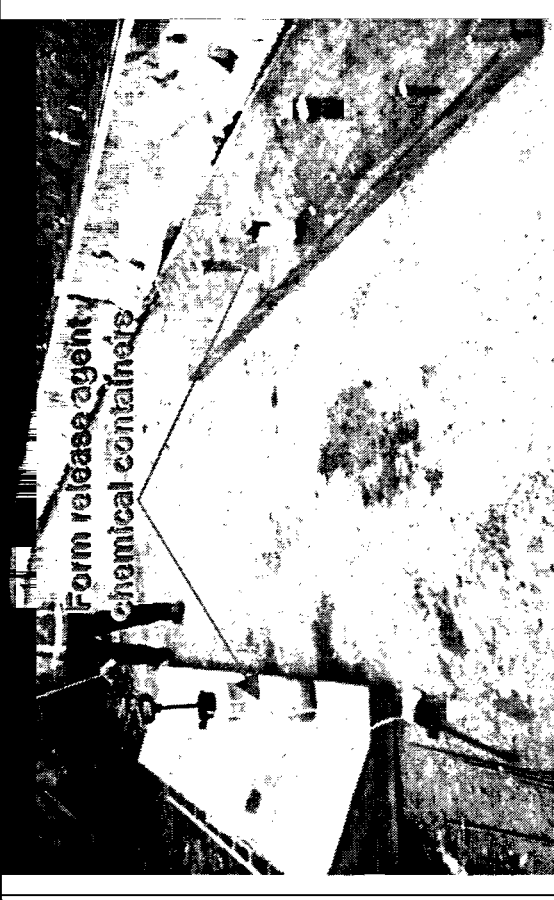
Adequate BMPs were not implemented at the construction site for good housekeeping to properly manage the storage of chemicals and materials on-site. Containers of various chemicals, including a form release agent and petroleum products, were improperly stored without secondary containment or coverage (see Photographs 8, 9, 10 and 11). In addition, a portable toilet was not staked into the ground or otherwise secured and was located adjacent to a steep slope (see Photograph 12).

<p>Form release agent chemical containers</p>
